SPOKANE INDIAN HOUSING AUTHORITY TRIP REPORT

Assessment of Mold and Moisture Conditions

Final Report

March 15 - 16, 2005

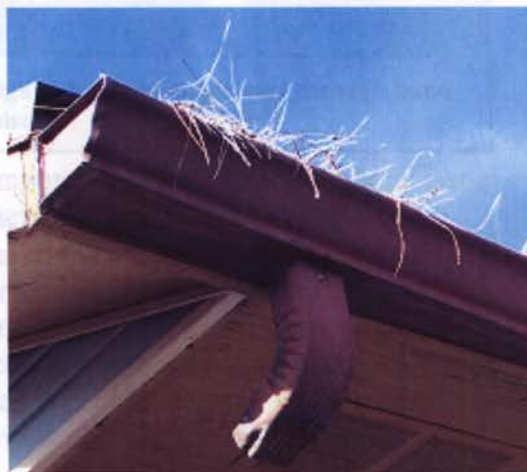
Many homes did not have gutter systems. Those that did were filled with pine needles. In wet climates, the lack of a gutter system can place a tremendous moisture load on the foundation and the house. However, it did not appear to pose a problem in this particular climate. The Spokane Indian Reservation receives less than twenty inches of precipitation per year. SIHA mentioned that remaining gutter systems were going to be removed because of the constant pine needle buildup (Figure 1).

Figure 1: Pine needles in gutters and missing downspout

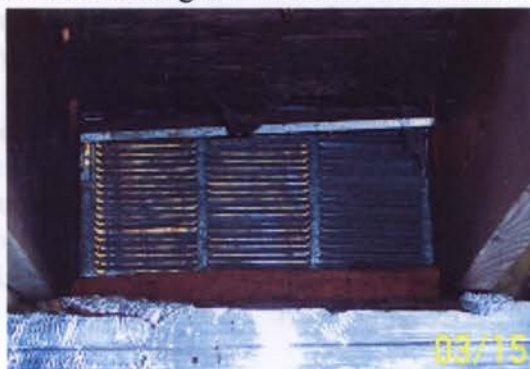
Figure 2: Crawl space vent through band joist

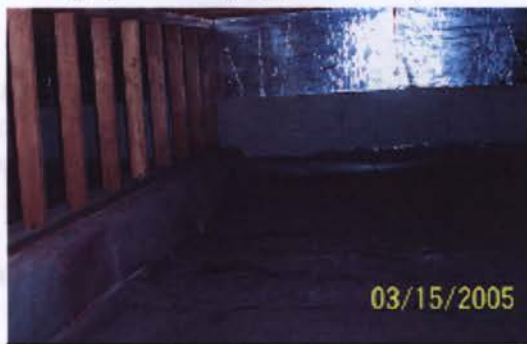
Most homes with crawl spaces had an effective vapor barrier (VB) (Figure 3) to keep ground moisture from dissipating up into the structure. None of the inspected crawl spaces had separate sheets of VB sealed to one another. Although this may not be a significant issue in regard to moisture, it is with radon. Radon is a gas which should be contained beneath the VB or vented to the exterior. Sealing individual pieces of VB to one another and sealing along the VB perimeter is important. This is particularly an issue

Figure 3: Well installed vapor barrier

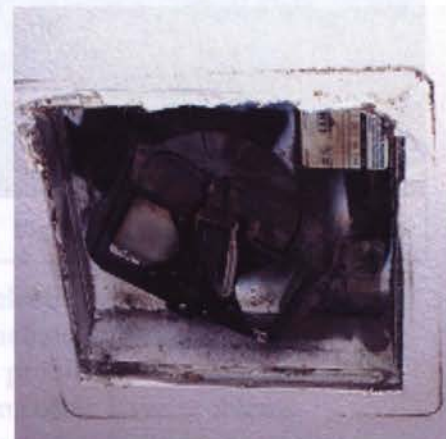
One home had an inoperable bathroom fan (Figure 4), one home had a bathroom fan that vibrated excessively and was

Figure 4: Inoperable bath fan

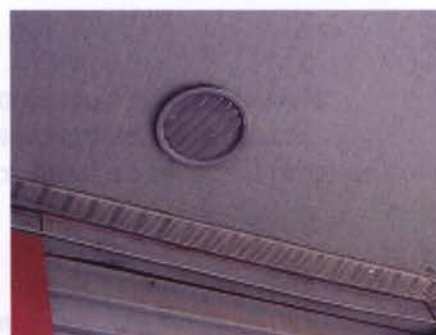
Figure 5: Undersized bath vent next to soffit vent

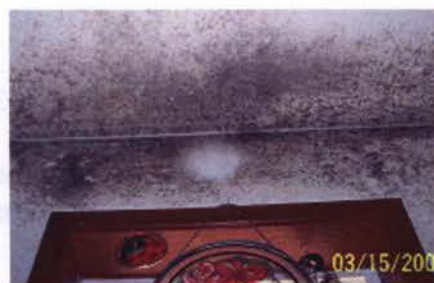
High indoor relative humidity during the winter can result in condensation based mold growth on a cool interior surface (Figure 7). This commonly occurs at the exterior wall/ceiling juncture, particularly on older, wood frame structures with low-sloped roof pitches. This building condition restricts careful placement of ceiling insulation (reducing R-value) and is affected by cold winds through the soffit vents that then washes through the insulation. Several homes had this problem in the bathroom, the room with the highest humidity

Figure 7: Mold at wall to ceiling juncture in bathroom

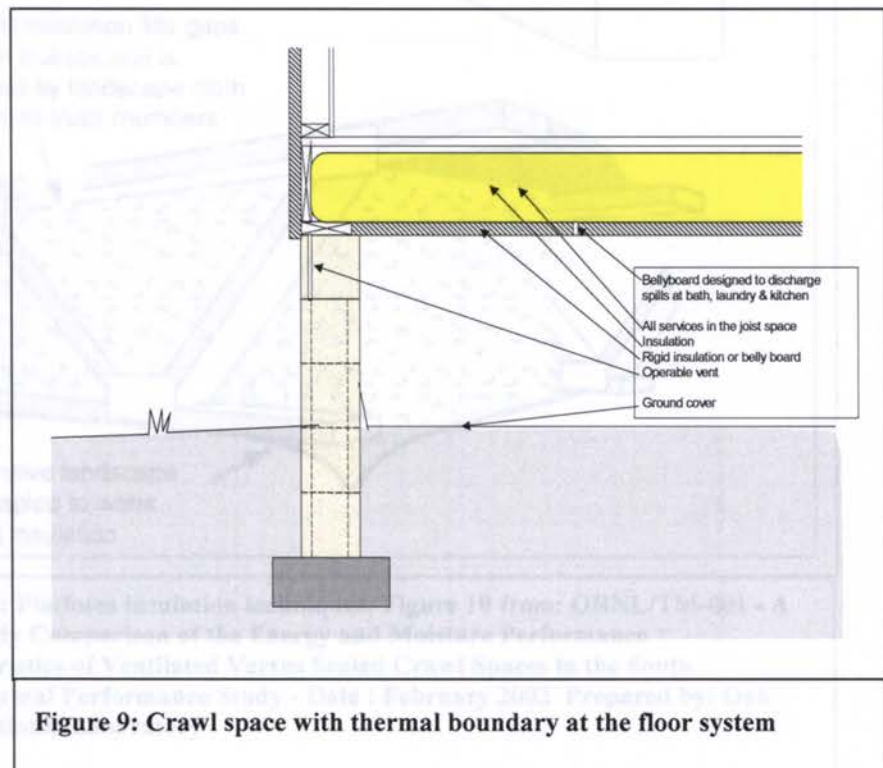
Figure 9: Crawl space with thermal boundary at the floor system

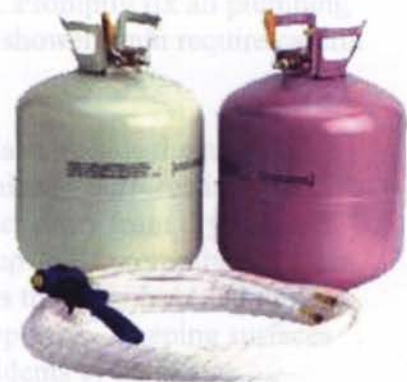
Spray polyurethane foam has an R-value of 6 per inch. It is also impermeable to air flow. The foam should provide the necessary insulation and air seal to elevate the interior surface temperature of the wall/ceiling juncture.

Figure 13 – Two-part spray polyurethane foam

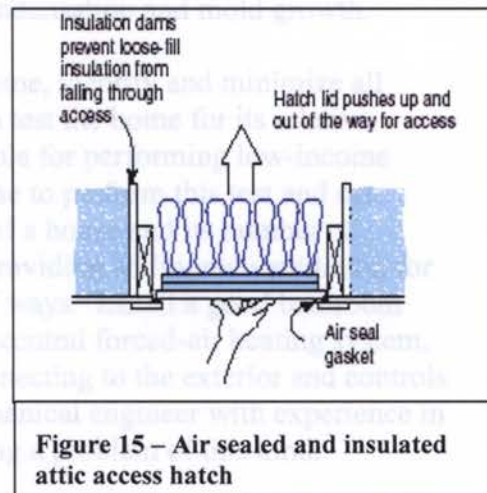
Figure 15 – Air sealed and insulated attic access hatch

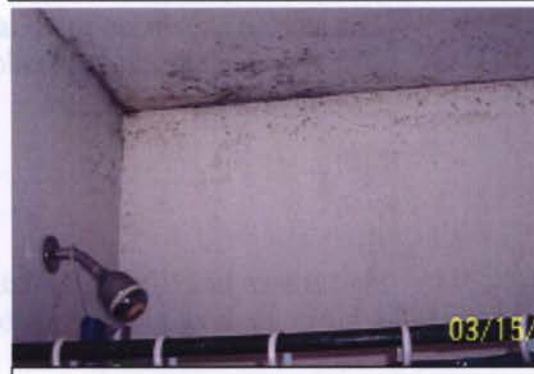
Figure 3: Mold at wall to ceiling junction above bathtub

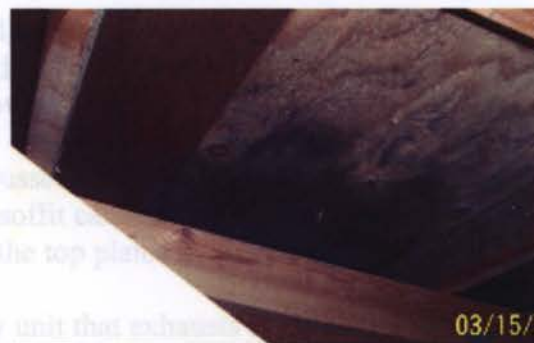
Figure 4: Mold on roof sheathing

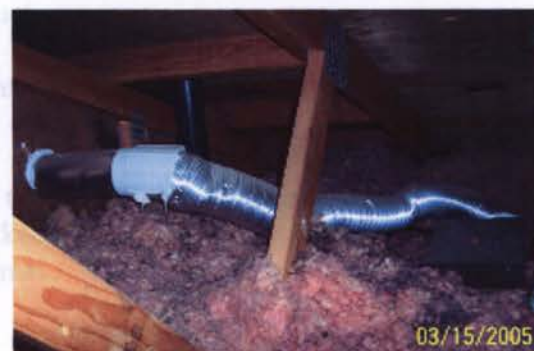
Figure 5: Possible leaky bath fan duct

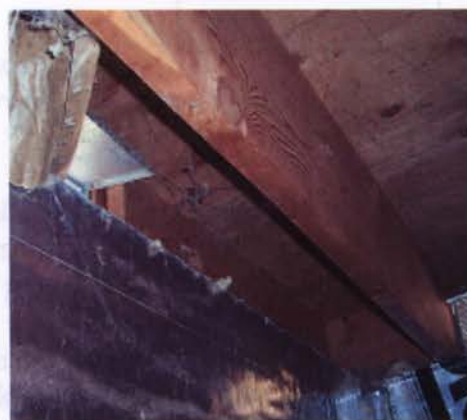
Figure 3: Missing rim joist insulation

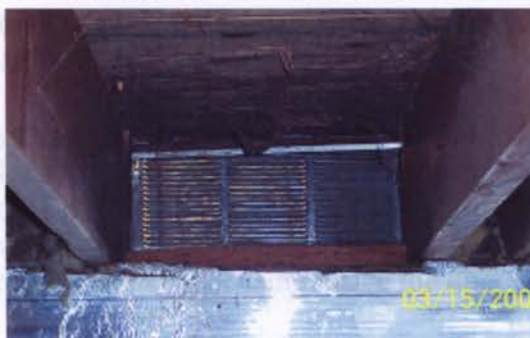
Figure 4: Crawl space vent directly next to plywood subfloor

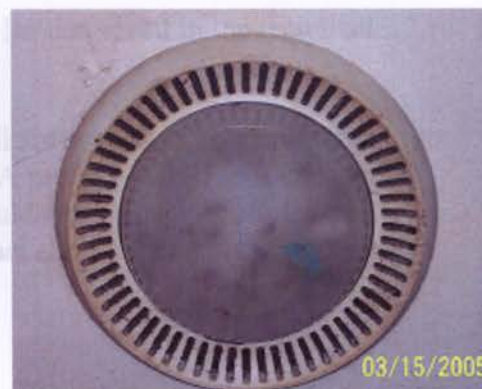
Figure 5: Clogged bathroom fan grill

6. Inform the homeowner that the bath fan grill should occasionally be vacuumed to keep the air intake holes free of lint and dust.
7. When not in use, keep the bath door open so that heat and air can migrate into the room, or use the electric heater to keep the room warm. Keeping the room warmer will help mitigate mold problems.
8. Clean mold from windows and draw window coverings back during daytime hours to allow air to circulate over glass.
9. Replace missing insulation sections in crawl space.
10. Install a minimum of 1" thick rigid insulation tight to the subfloor at each crawl space vent extending approximately 2' beyond the rim joist.
11. The venting of the range hood is suspect. There appears to be a small area of mold on the roof sheathing above the range hood. The ducting of the hood should be inspected and an appropriate soffit vent with back-draft damper should be installed.

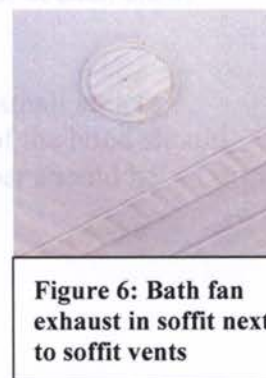
Figure 6: Bath fan exhaust in soffit next to soffit vents

4. Install a timer or time-delay switch for the bath fan [as described in the technical section of the report].
5. Currently the bath fan duct exhausts through a small soffit vent. The vent is far too small and constricts the flow of air (Figure 6). A properly sized roof cap, wall cap, or soffit vent should be installed. The cap should have a back-draft damper to keep cold air from blowing into the duct. The duct should be insulated to keep warm moist air from condensing inside the duct

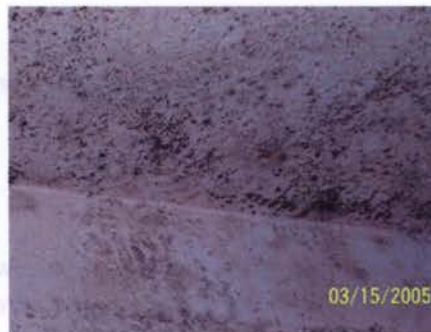
Bathroom: The toilet was securely fastened to the floor. The bath fan, operated by a separate switch, was not being used; it vibrated excessively and quickly burned out light bulbs. It exhausted with low efficacy to an undersized round vent in the soffit (Figure 5). Mold compromised most of the ceiling and extended down the walls to the tub surround.

Figure 2: Mold on walls and ceiling in bathroom

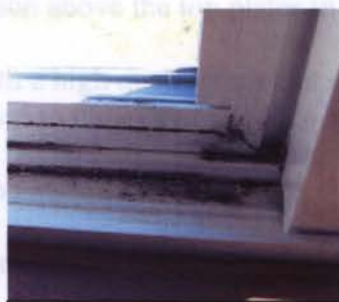
Interior Conditions: The interior was in good condition. Mold was present on the bedroom window sills, but condensation was not reported. The bedroom was on the colder side of the home. Three fish tanks were present in the

Figure 4: Dirt and mold on the bedroom window sill

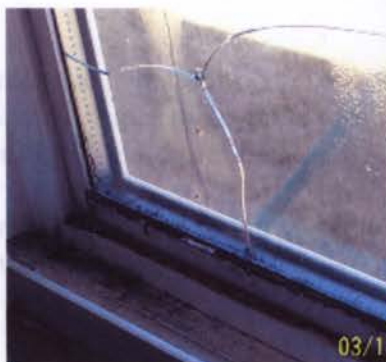
Figure 8: Broken window and dirt on window sill

1. Replace the broken window and replace compromised window trim.
2. Refinishing and resealing siding

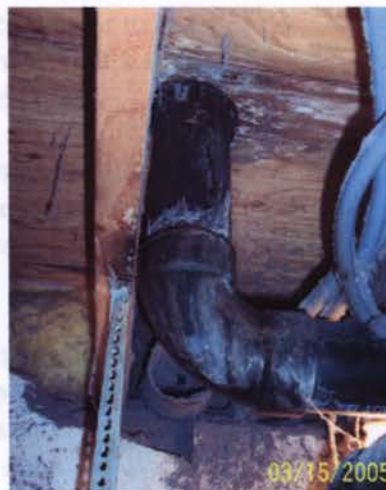
Figure 6: Evidence of plumbing leaks and disconnected dryer vent in background

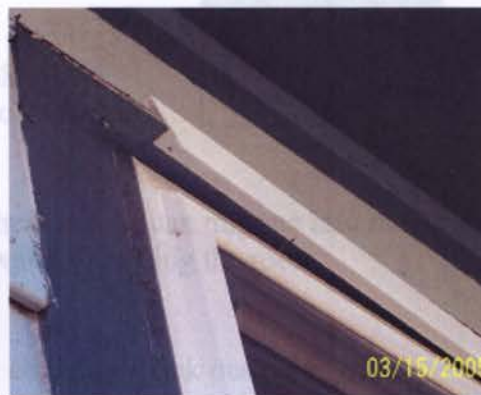
Figure 7: Loose and missing trim strips around window frame

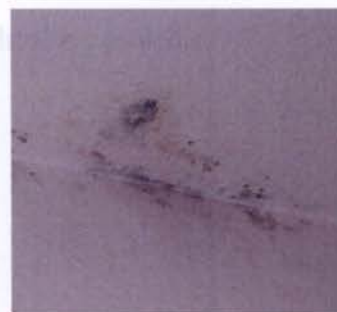
Mold and Moisture Conditions: Mold was present in the bathroom at the wall to ceiling junction (Figure 2) and on the attic sheathing (Figure 3).

Figure 2: Mold at wall to ceiling junction in bathroom

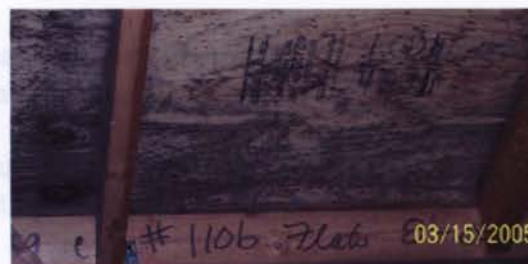
Figure 3: Mold on attic sheathing

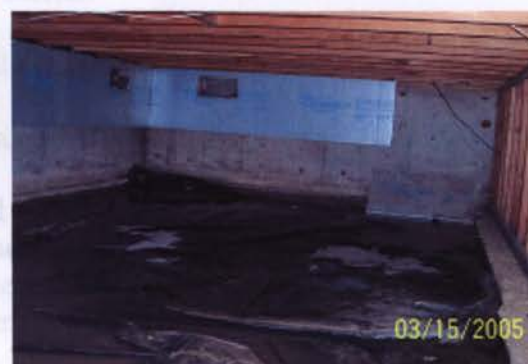
Figure 5: Water in the crawl space and loose insulation

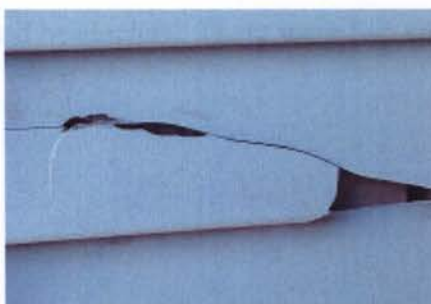
Figure 6: Cracked vinyl siding

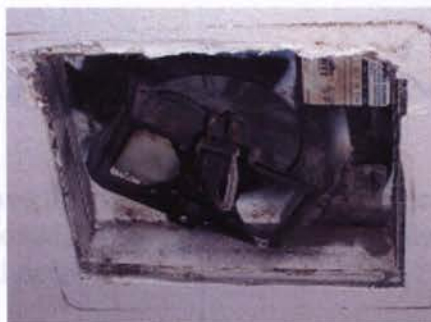
Figure 7: Inoperable bath fan

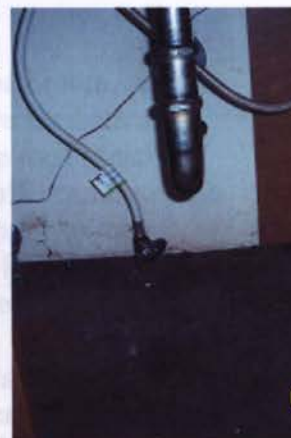
Figure 9: Former leaky kitchen plumbing

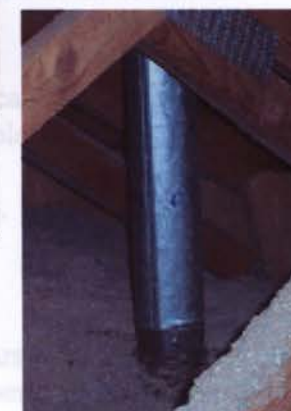
Figure 11: Uninsulated bath fan duct

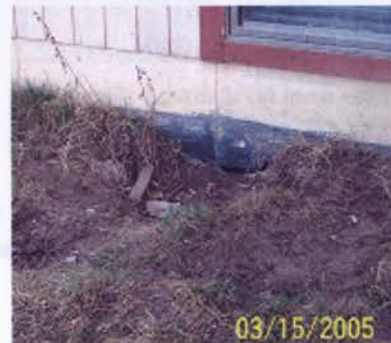
Figure 4: Depression next to foundation

1. Repair soffit.
2. Fill and re-grade depressions near the foundation.
3. Replace the undersized bathroom vent with an appropriately sized wall vent for the lower bathroom (Figure 7), and an appropriately sized soffit vent for the upstairs bathroom. Both vents should have a back-draft damper.

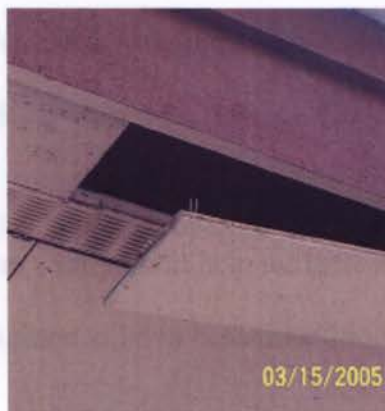
Exterior Conditions: The metal roof and wood siding were in good condition. No gutters were present. A section of soffit material was missing and other sections were loose (Figure 6).

Figure 6: Failing soffit material

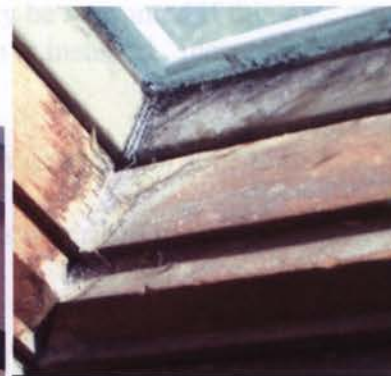
Figure 5: Window sash deterioration due to condensation

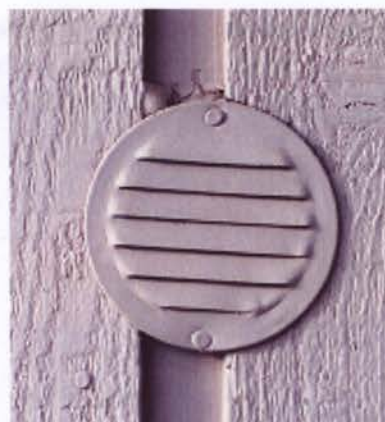
Figure 7: Lower level bath vent exhaust

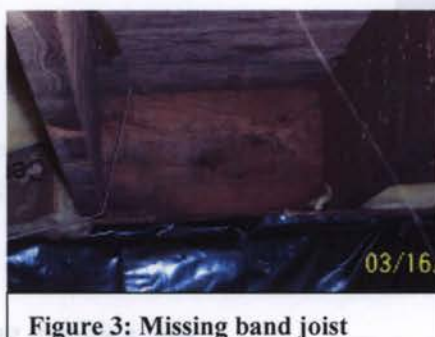
Crawl Space Conditions: The crawl space was dry with a vapor barrier present. The walls and band joist were insulated, though sections of the band joist insulation were missing (Figures 2 & 3).

Figure 3: Missing band joist

1. In crawl space, replace missing insulation sections along the perimeter band joist and insulate those areas that were never insulated.
2. Repair washing machine leak.
3. Replace re-circulating kitchen exhaust fan with one vented to the exterior.
4. The crawl space ventilation system should be disabled. See the Technical Section of the report for a more detailed discussion regarding the concerns with the existing system.

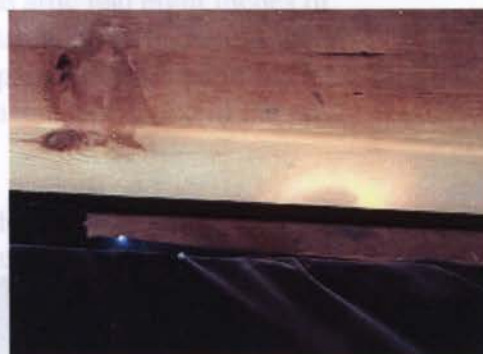
Figure 2: Missing band joist insulation

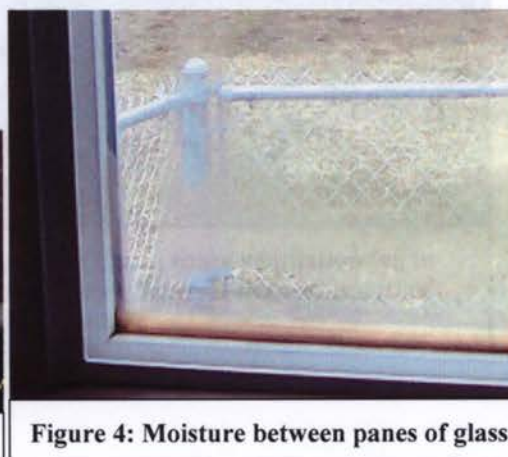
Figure 4: Moisture between panes of glass

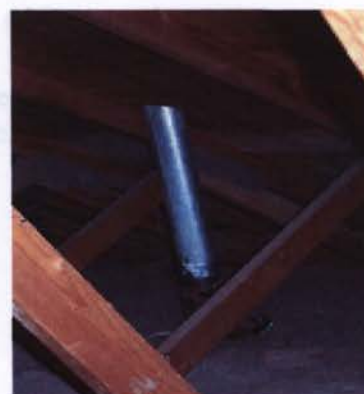
Figure 5: Uninsulated bathroom duct in the attic

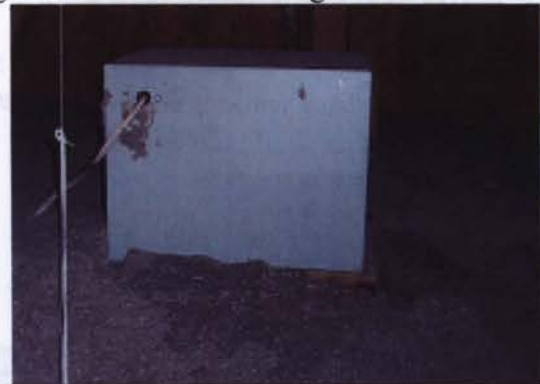
Figure 1: Crawl space ventilation fan in attic, note evidence of wetted insulation around unit

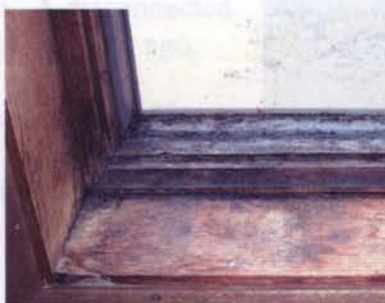
Figure 3: Water damage to window sash and sill

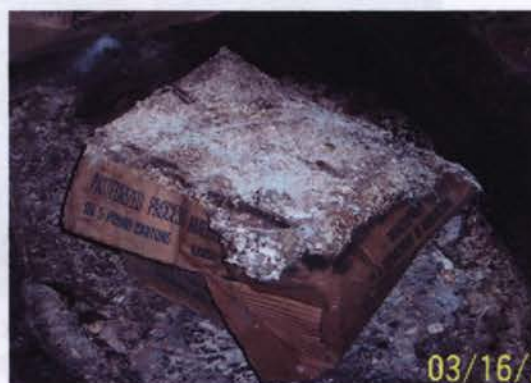
Figure 4: Moldy cardboard in crawl space

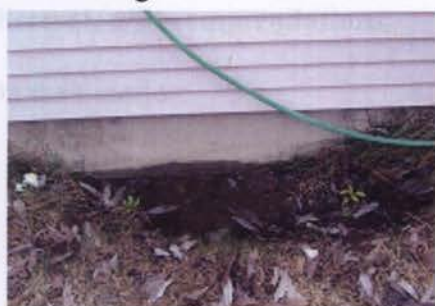
Figure 5: Puddle in a depression next to the foundation wall

1. Fill and re-grade depressions near the foundation.
2. Repair vinyl siding.
3. Remove gutter system.
4. Fix the broken dryer vent exhaust.

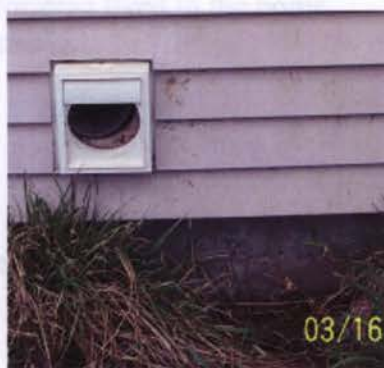
Figure 6: Broken dryer exhaust and depression next to foundation

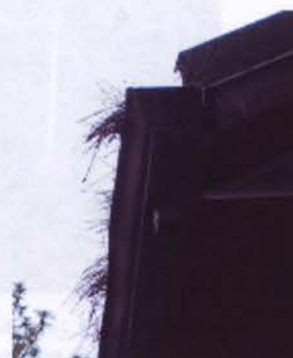
Figure 7: Missing downspout and pine needles in gutter

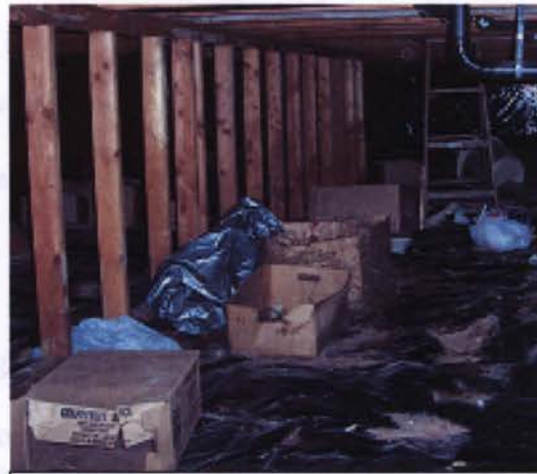
Figure 8: Food for mold in crawl space

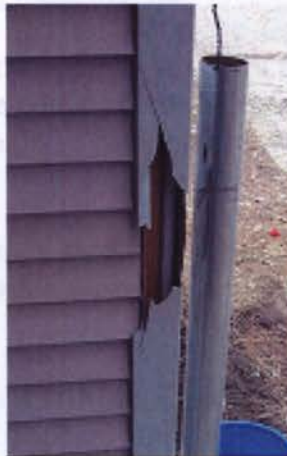
Figure 9: Damaged vinyl siding

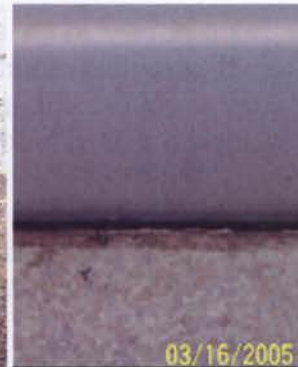
Figure 10: Open seam between vinyl flooring and bathtub

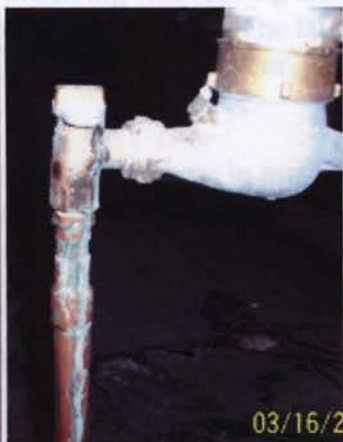
Figure 4: Actively leaking water meter in crawl space

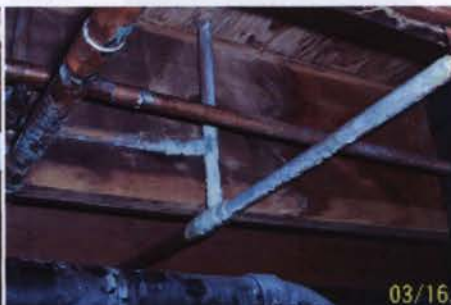
Figure 5: Evidence of water leakage

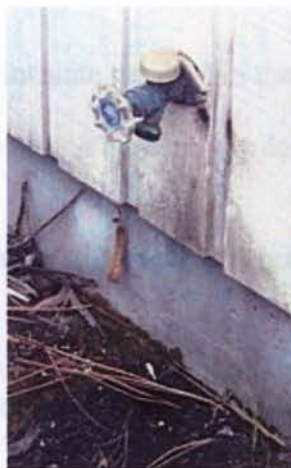
Figure 6: Leaking spigot

1. Fill and re-grade depressions near the foundation.
2. Repair leaking spigot.
3. Remove gutter system.
4. Clean and repaint molded soffit section.

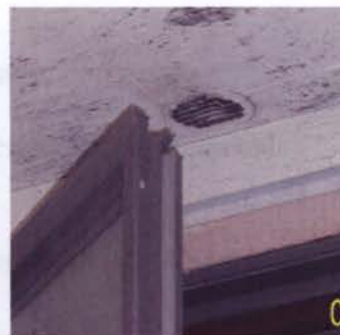
Figure 7: Bathroom vent next to bath window

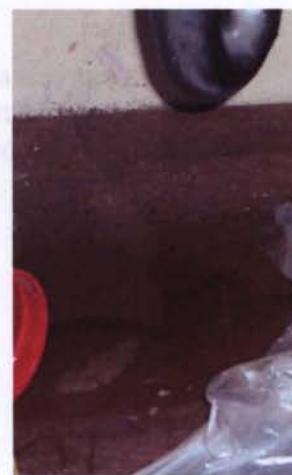
Kitchen: The electric stove had a range hood exhausting to the exterior. The kitchen sink waste plumbing was leaking and there was standing water on the cabinet base (Figure 8). The laundry room sink was also leaking; both were fixed during our assessment.

Figure 8: Standing water in base of kitchen cabinet

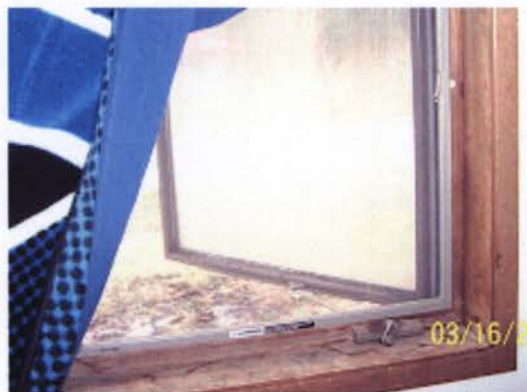
Figure 9: Heavy window covering, moisture between panes of glass, and moisture damage to sash and sill
